**When global technology manufacturer Compac Sorting Equipment wanted to create a showroom floor to impress their international clients, they called upon leading NZ flooring applicators, Topcoat Specialist Coatings Limited.**

**SCOPE:**  
1,000sqm showroom/prototype area

**CATEGORY:**  
Floor epoxy re-topping/coating

**PRODUCT:**  
PPG Amerlock 400 in Denaube

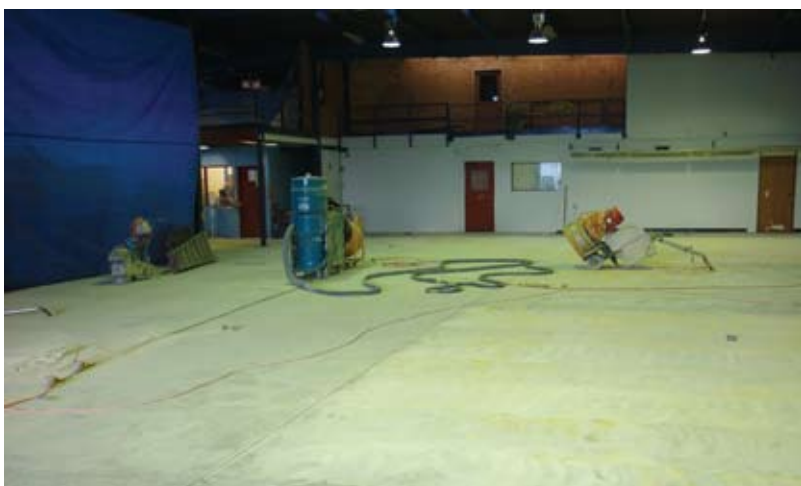
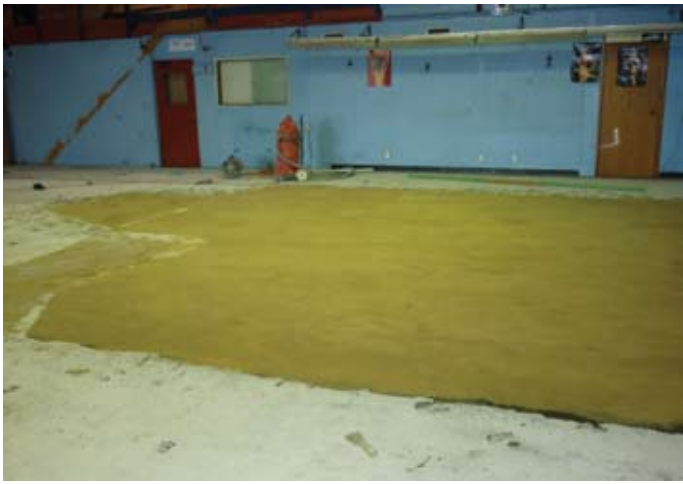
The challenge for Topcoat was to transform a pitted and delaminated concrete base into a glossy new floor of showroom standard.

The original floor had surface pitting, oil contamination, and uneven surfaces due to a mix of different leveling compounds.

This process involved an initial grind, kango-ing off loose delaminated topping, laying an epoxy pre-fill to level uneven areas, and a re-grind. The final step was to apply three coats of PPG Amerlock 400 roll-on epoxy, in the chosen colour of Denaube.
